H. B. NORTON DAM  
(PA NO NAME No. 42)

NDI No. PA 00385  
PennDER No. 24-35

PHASE I INSPECTION REPORT  
NATIONAL DAM INSPECTION PROGRAM

February 1979

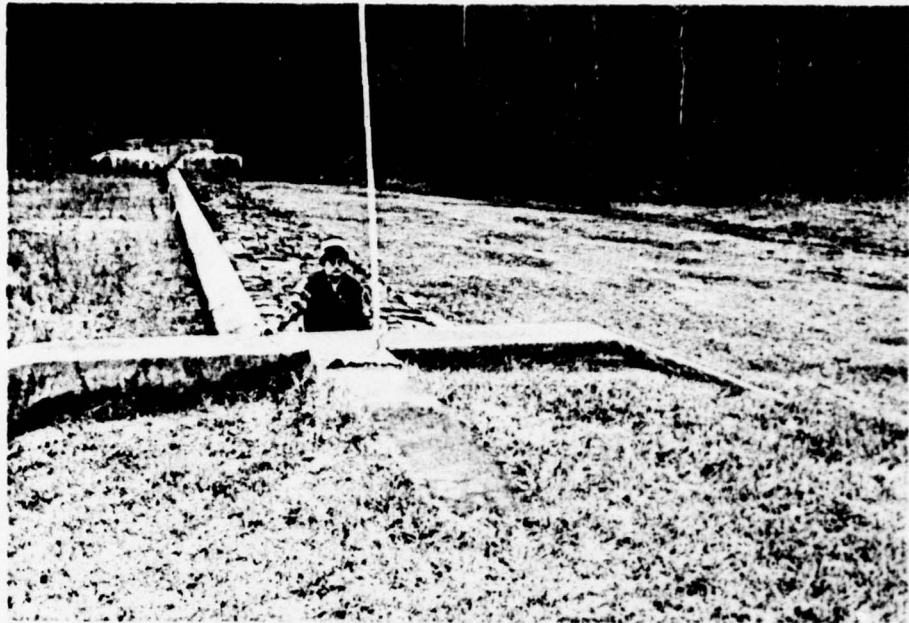
**PHOTO 1. View of Emergency Spillway Looking Left to Right  
from Crest of Dam**

- c. Appurtenant Structures - The emergency spillway concrete has deteriorated and spalled along the sill, and a large crack was observed in the right abutment retaining wall. Cracks were also found in the principal spillway abutments. There was also a crack at the joint of the right abutment and the transition buttress of the emergency spillway. The concrete on the outer surfaces of the screen chamber access located on the crest of the dam showed signs of cracking and spalling. The intakes for the 36-inch and 16-inch cast-iron pipes were inaccessible. However, the outlet structure for the 36-inch pipe encased in concrete appears to be in fair condition and showed no signs of excessive deterioration. The 16-inch outlet to the pump house was also inaccessible and therefore no evaluation could be made of its condition.

- Photo 1 - View of Emergency Spillway Looking Left to Right  
from Crest of Dam  
(Note cracking of concrete and erosion of crest  
along wing wall.)
- Photo 2 - View of Emergency Spillway Outlet Channel

- 4) The trees along the top of the wall of the downstream principal spillway (right side) should be removed or trimmed to facilitate future inspection of the wall.
- 5) The bush-like vegetation that is on the downstream slope should be removed, and the slope should be treated and seeded with an appropriate mixture to prevent erosion.
- 6) The concrete wing walls, transition buttresses, and spillways should be repaired where cracking and spalling has occurred.

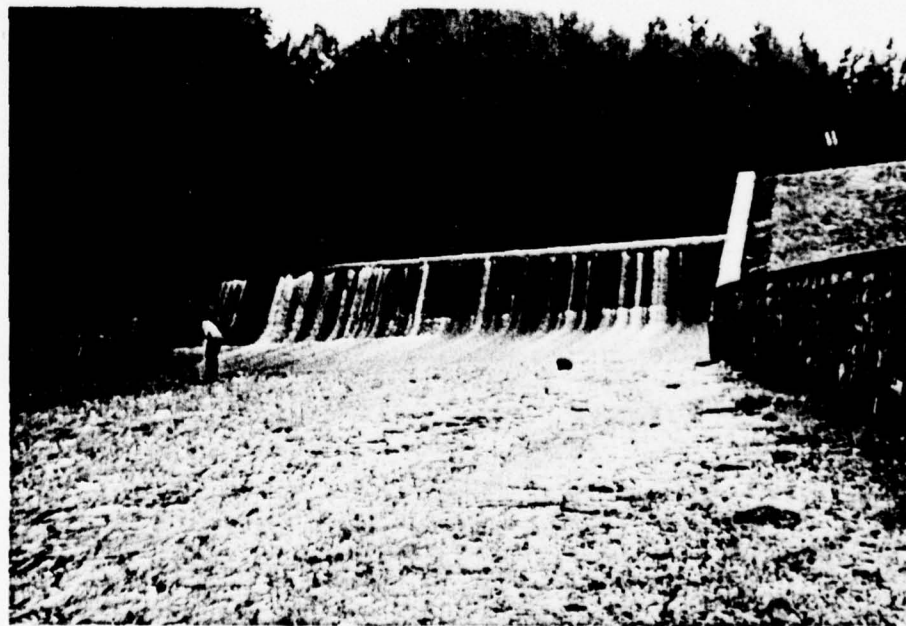
PHOTO 4. View Showing Ogee Weir Spillway

VISUAL EXAMINATION OF	OBSERVATIONS	REMARKS OR RECOMMENDATIONS
CONCRETE WEIR	Principal spillway consists of a 75-ft. wide concrete ogee-section. The spillway abutments are cracked in several locations. There is also a crack at the joint of the right abutment and training wall. The 2-ft. wide, 150-ft. long concrete sill at the emergency spillway shows signs of cracking and spalling at several locations. There is a 10-ft. wide strip of cut stone riprap on the downstream side of the sill which is in fairly good condition.	The concrete on both spillways should be repaired.
APPROACH CHANNEL	The approach channel to the principal spillway is free of debris, erosion and obstructions. The approach to the emergency spillway consists of earth and low grasses. No obstruction or serious erosion was noted.	
DISCHARGE CHANNEL	The principal spillway channel is stone-lined, approximately 230 ft. long, and 75 ft. wide. Some differential settlement of the stone was observed. This channel exits into a natural stilling pool. Both the stilling pool and channel are relatively free of debris and other obstructions. The emergency spillway discharge channel consists of an earth channel covered with low grasses, having an average slope of about 5%. This channel joins Big Mill Creek several hundred feet downstream. No debris or obstructions were located in the channel.	The differential settlement of the stone does not appear to be a serious problem.

- Photo 4 - View Showing Ogee Weir Spillway  
(Note cracks along wing wall.)
- Photo 5 - View of Head Wall of 36-Inch Blow-Off Pipe  
(Note the bush-like vegetation on the downstream  
embankment. The valve used to regulate the flow  
of the 36-inch pipe is located at the base of the  
slope adjacent to the steps.)

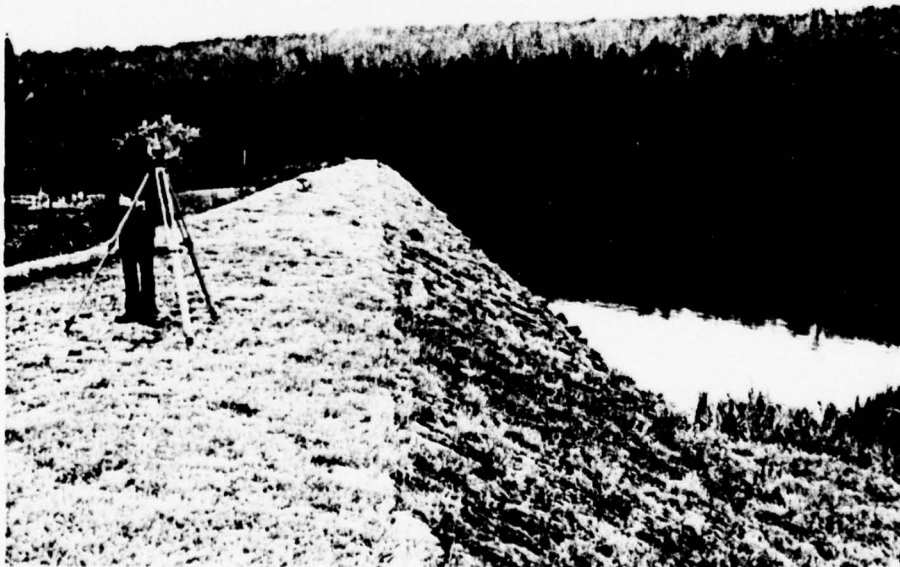
**PHOTO 8. View Looking at Crest and Upstream Slope**

- b. Dam - The riprap on the upstream face, from the water level to 4 feet above the water level, has settled due to erosion of the material between and under the sandstone boulders. The crest has eroded from 6 to 12 inches on the upstream face, and erosion has exposed the transition buttresses at both ends of the embankment. On the downstream face just right of the principal spillway, a 2-inch deep gully has developed from approximately mid-height of the dam to the toe. The downstream slope has numerous bush-like plants growing from the crest to the toe. Also, several rodent holes were found on the downstream face (see field sketch for location). No outlets were found for the tile drains.

VERTICAL AND HORIZONTAL ALIGNMENT OF THE CREST	The crest on the upstream side is eroded from 6 to 12 in.	The crest area should be graded, treated and seeded with an appropriate seeding mixture to prevent erosion.
RIPRAP FAILURES	Several locations of the riprap on the upstream face at the water level to 4 ft. above it have settled due to erosion of the material between and under the boulders.	The riprap should be restored to its original position with a granular cushion/filter under the riprap.

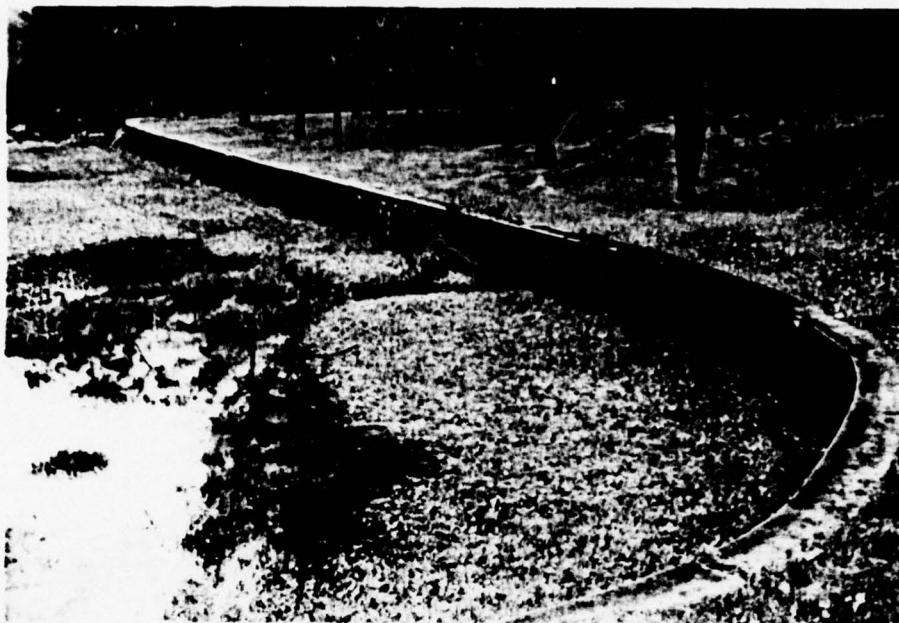
**PHOTO 9. View Looking Downstream at Seepage Area**

- a. Visual Observations - No structural inadequacies were noted during the visual inspection of the dam. The seepage areas indicated in paragraph 3.1.e. are not considered detrimental to the stability of the dam according to the conditions present at the time of inspection. The seepage from the sandstone wall may be from the area behind the sandstone wall or possibly from the tile drains under the dam that were not outletted properly. The wet areas below the emergency spillway may be a result of natural springs or seeps in the area.

- 2) The drain outlets for the tile drain, located in the area behind the steel sheet core wall, should be located and extended to an outlet channel. The quantity and turbidity of all seepage should be monitored and recorded. If conditions indicate the necessity, remedial measures should be taken.
